Improving Ecological Function of a Stream and Wetland site at Swan Lake Christmas Hill Nature Sanctuary

Tomas Lang

Edited June 4 2021, Originally Submitted April 9, 2021

ER311 – University of Victoria

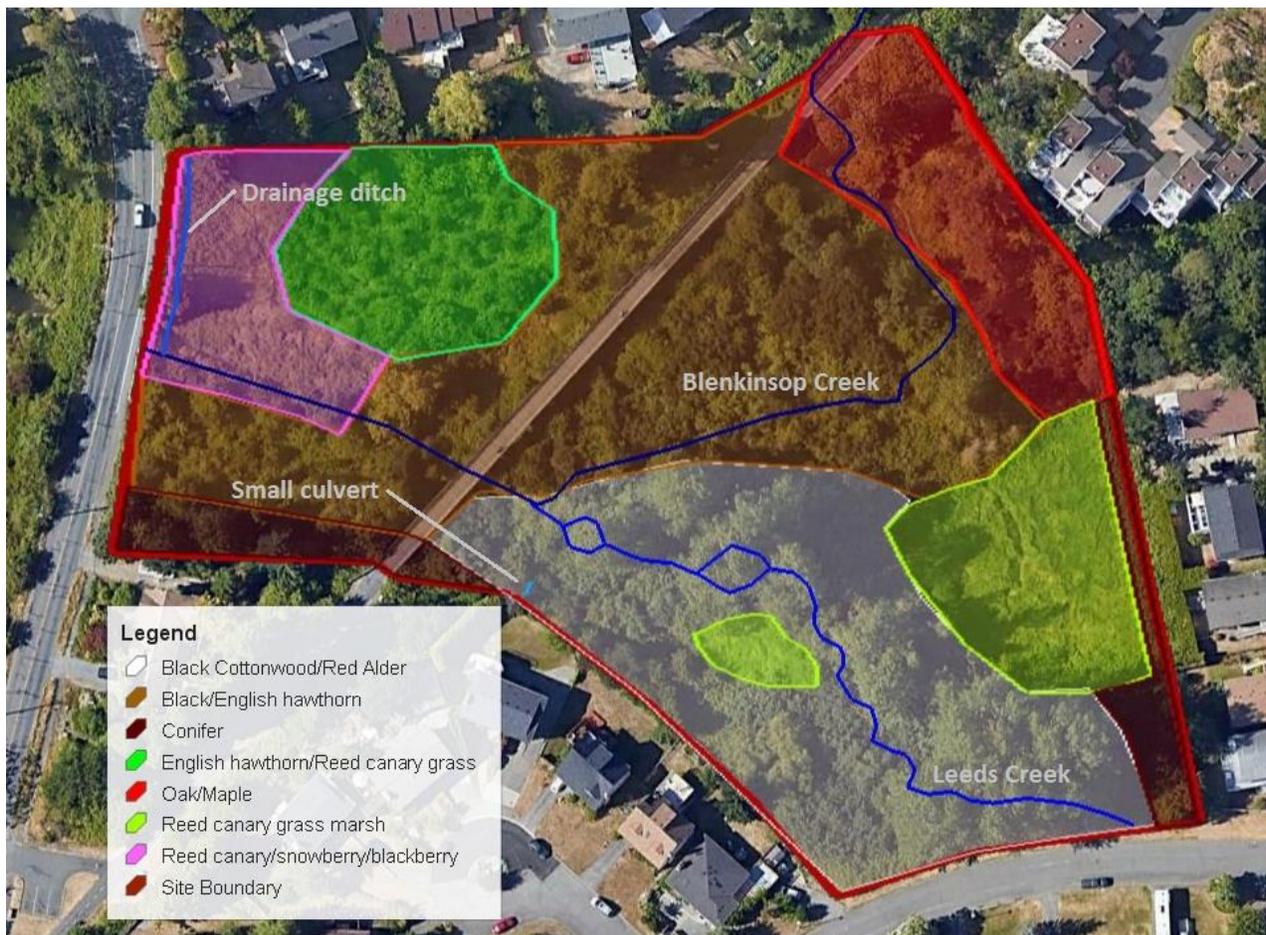
Figure 2: Map of Plant Communities and Waterways

The site is on a substrate of marine clay (Townsend 2009; 2010) and presents a mosaic of different wetland plant communities with many native species present, although they are predominantly one age class. Seven main plant communities were distinguished, and most seem fairly vigorous (see Figure 1 and Table 1). It is separated from the main SLCHNS site by Saanich Road, surrounded almost entirely by houses and roads, except one small section that extends briefly between buildings on the east side. Observed animal use of this site includes deer (browsing and antler rubbing), racoons (tracks seen), and birds (foraging, mud probing, and nesting). Most areas lack significant large woody debris, although Leeds Creek and the adjacent wetlands contain a significant amount. Petrochemicals and other pollutants were noted, and garbage was abundant. The water is assumed to be nutrient-rich and polluted due to agriculture runoff and the urban environment. The streams are extremely reactive to rainfall (Rastogi, SLCHNS Site Manager, Personal Communication, 2021), receiving a large amount of stormwater from impervious areas in the urban environment.

Blenkinsop Creek is ditch-like, lacking sinuosity and adequate bank stabilizing species with vertical or near-vertical banks. This stream was historically much smaller, channelized to drain the wetlands surrounding Blenkinsop Lake around the late 1800s or early 1900s (Buchanan et al. 2009). It was deemed non-functional based on Proper Functioning Condition standards (Buchanan et al. 2009), appearing similarly today. Erosion is seen in multiple areas, for example sloughing, and a severely undercut bank where the stream has eroded underneath a stabilizing shrub. The clay substrate slows the effects of erosion (Buchanan et al. 2009). The stream contains minimal large woody debris, although in three instances garbage (e.g. milk crates, furniture) formed complexes functioning similarly to large wood. The entrenchment of the creek means that the surrounding floodplain is difficult to access, however due to reactivity to storms this likely still occurs relatively frequently. Buchanan et al. (2009) project this stream as a potential Rosgen channel-type C6, which it appears to be working towards through eroding banks and mild increases in sinuosity.

Leeds Creek, emerging from a culvert at the SE corner of the site, is in significantly better condition than Blenkinsop Creek. It is quite sinuous, with banks largely vegetated with Slough sedge (*Carex obnupta*) and riparian shrubs and trees such as Willows (*Salix spp.*). The surrounding floodplain is more easily accessible than for Blenkinsop Creek, looking similar to the reference site (see Tables 3 & 4 for reference site details). In multiple locations, windthrown trees have altered the stream's path, and the point bars created by these events are revegetating, a positive indicator of stream function (Buchanan et al. 2009). It also has a

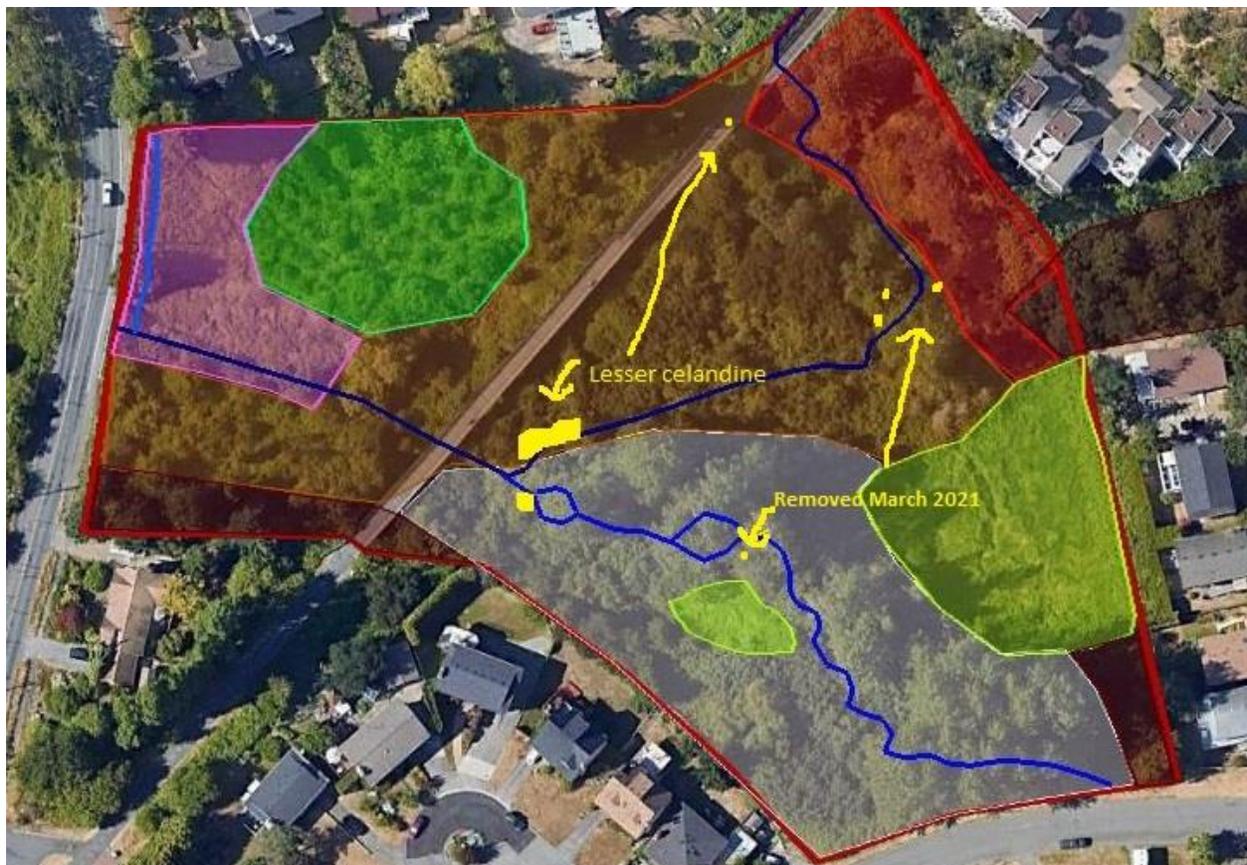
Appendix B: Map of known Lesser celandine presence

Invasive species are abundant, especially English ivy (*Helix hedera*) which dominates many areas. Notably, two established communities and some dispersed individuals of Lesser celandine were found, the first sighting at SLCHNS (see Appendix B, map of known locations). There is a community of Fawn lilies (*Erythronium oregonum*), a valued and delicate species, in the NE corner of the site, where SLCHNS and volunteers removed English ivy about six years ago (Rastogi, SLCHNS Site Manager, Personal Communication, 2021), which is currently being overtaken by English ivy again.

In the meantime, focus could be directed in other areas: invasive species control, garbage removal, and supporting stand regeneration (see table 4 for detailed recommendations). Targeting novel invasive species such as Lesser celandine should be prioritized, along with selective control of English ivy which is climbing up trees and overtaking the Fawn lilies. If there is a sufficient concentration of Black hawthorns in the central area, English hawthorns (*Crataegus monogyna*) could be girdled to create standing deadwood and create space for younger native shrubs. The integrity of the Leeds Creek area could be improved by planting shrubs to assist stand regeneration, as well as increasing the population of appropriate herbaceous layer species such as Skunk cabbage and sedges.
