**Plan for Nesting
Habitat Rehabilitation for the
Western Painted Turtle
at
Swan Lake Nature Sanctuary**

Prepared by
Christian Engelstoff, MSc, RPBio
and
Kristiina Ovaska, MSc, PhD

June 2010

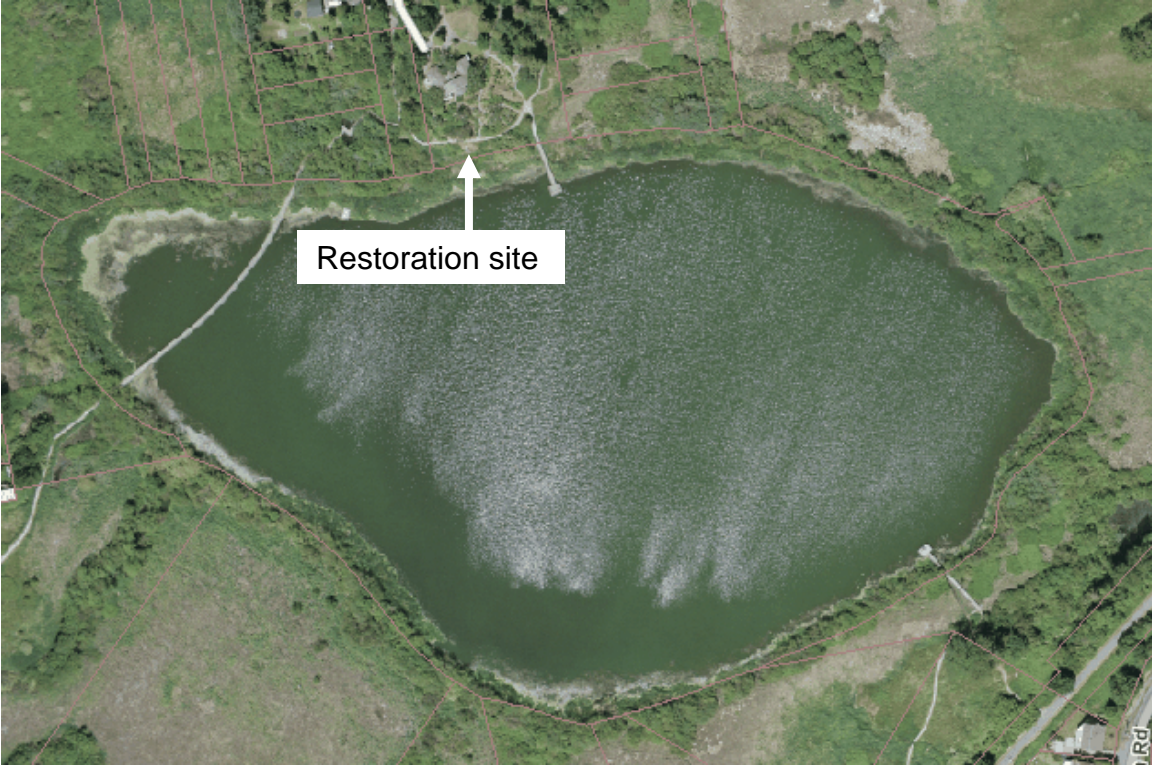
Figure 1. Location of the proposed site for turtle nesting site rehabilitation at Swan Lake Nature Sanctuary.

Figure 1 shows the location of the proposed nesting area. The site is located near the bottom of a hill and has a southern aspect. Exposed bedrock is present. The soil layer is mostly thin except on the east side. The ground is currently covered with introduced grasses (Figure 2). Scattered native plants (*Clarkia*, *Brodiaea*) are also present.

The proposed site has a suitable exposure and is located close to the lake (within 20 m), but both the substrate and access from the lake need to be improved.

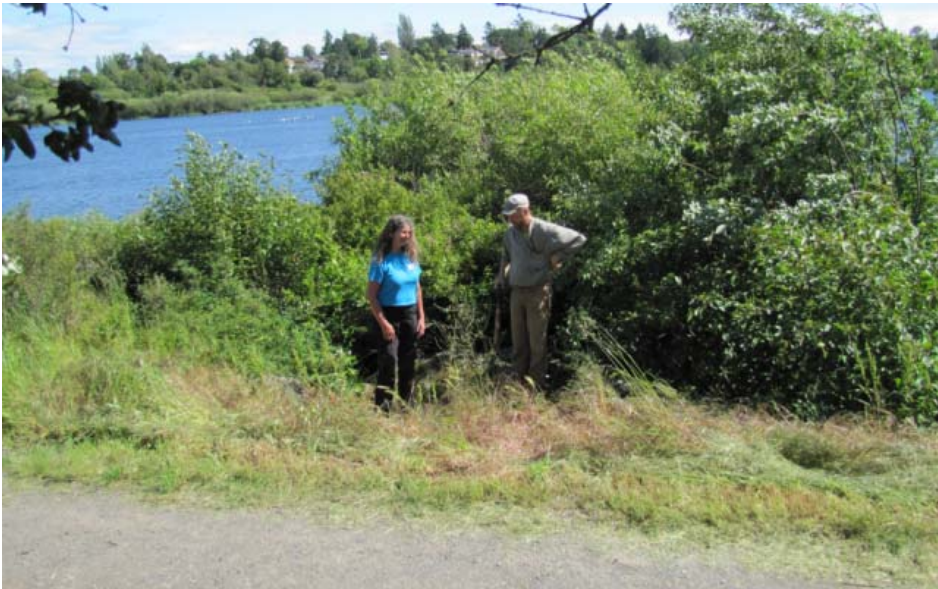
Figure 2. Habitat at the site proposed for rehabilitation.

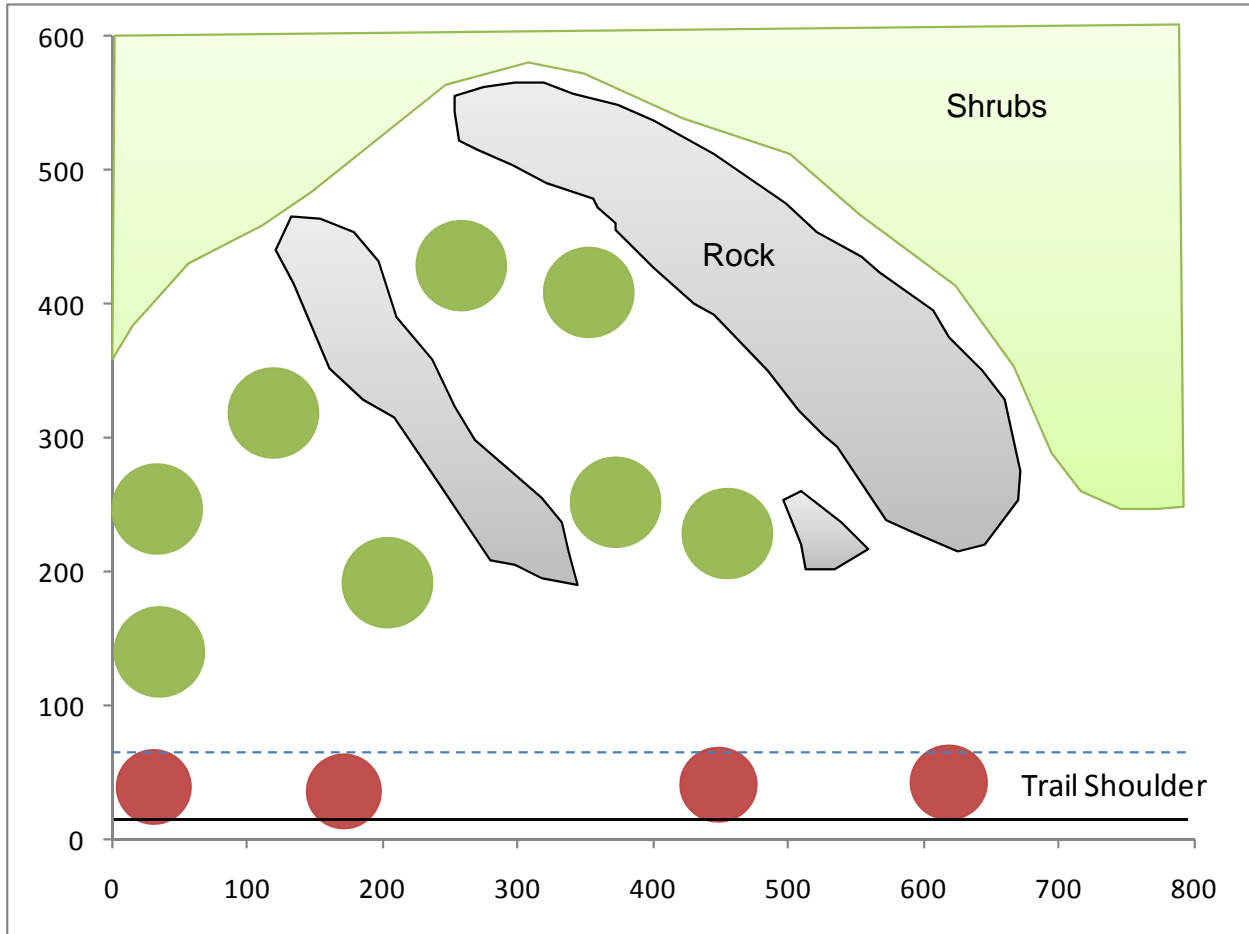
Figure 3. Schematic of turtle nesting area rehabilitation, showing circular areas to be rehabilitated as turtle nesting sites (green: larger plots of bare ground on the slope below the trail; red: smaller plots of bare ground on the level shoulder of the trail). Clumping native grasses and other low, slow-spreading native plants may be planted between the circular plots to provide cover and to enhance the appearance of the site.

- Bring in sand/soil as needed to create soil depth of about 20 cm and distribute as outlined in Figure 3.
- The area is to be set up as an experiment to test preferences of nesting turtles of substrate types of two different coarseness. There are six paired plots of treatments; each pair should be located in areas with similar slope and distance from the lake, and the treatments within each pair should be randomly allocated. In one of the treatments, only the soil present at the site will be used; in the other treatment, a substrate consisting of a mixture of 20% clay, 40% silt, and 40% sand (loam) will be used.
